INSTALLATION RESTORATION PROGRAM RECORDS SEARCH

For
Pease Air Force Base, New Hampshire

JANUARY 1984

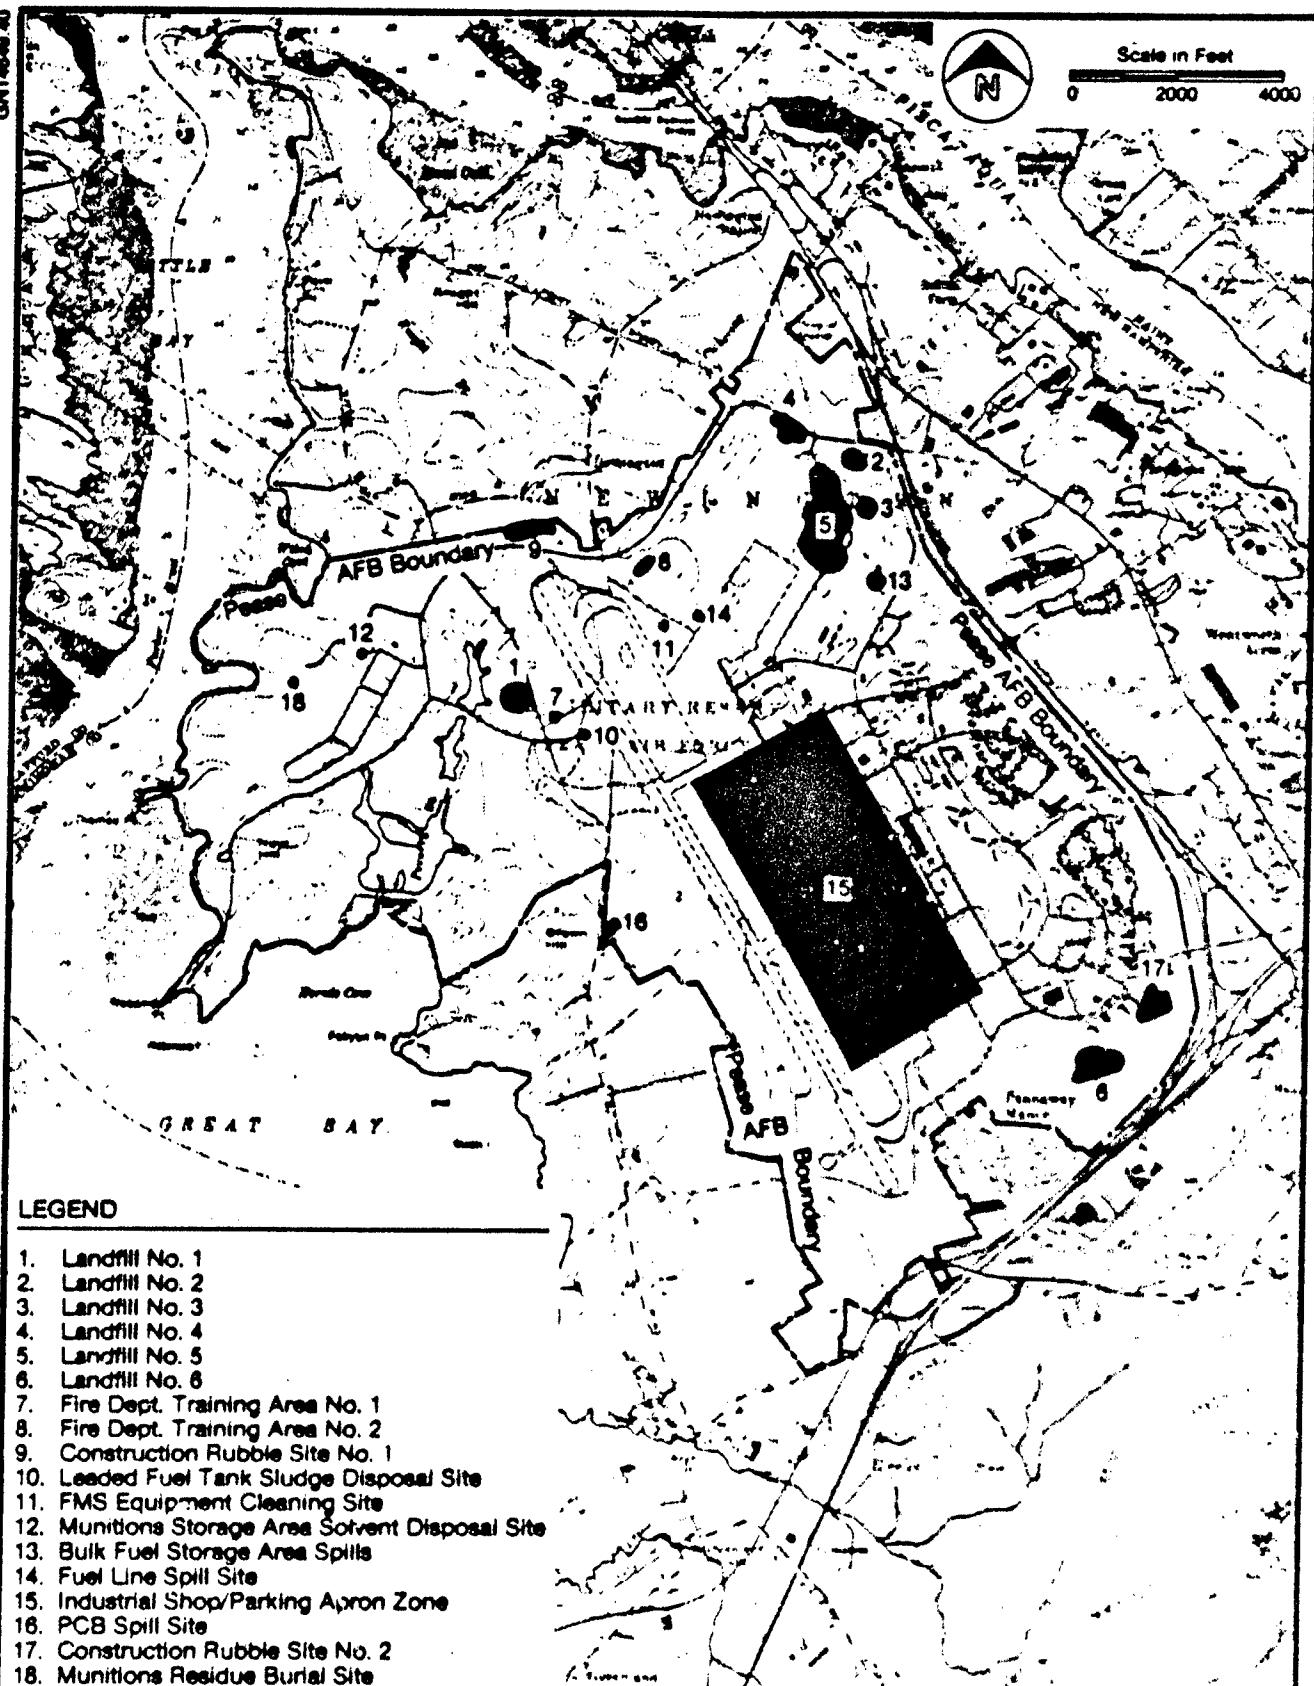
3. Interviews with past and present base employees resulted in the identification of 18 past disposal or spill sites at Pease AFB and the approximate dates that these sites were active. The location map of the identified disposal and spill sites is shown in Figure 1.

FIGURE 1.
Location Map of Identified Disposal and Spill Sites at Pease AFB.

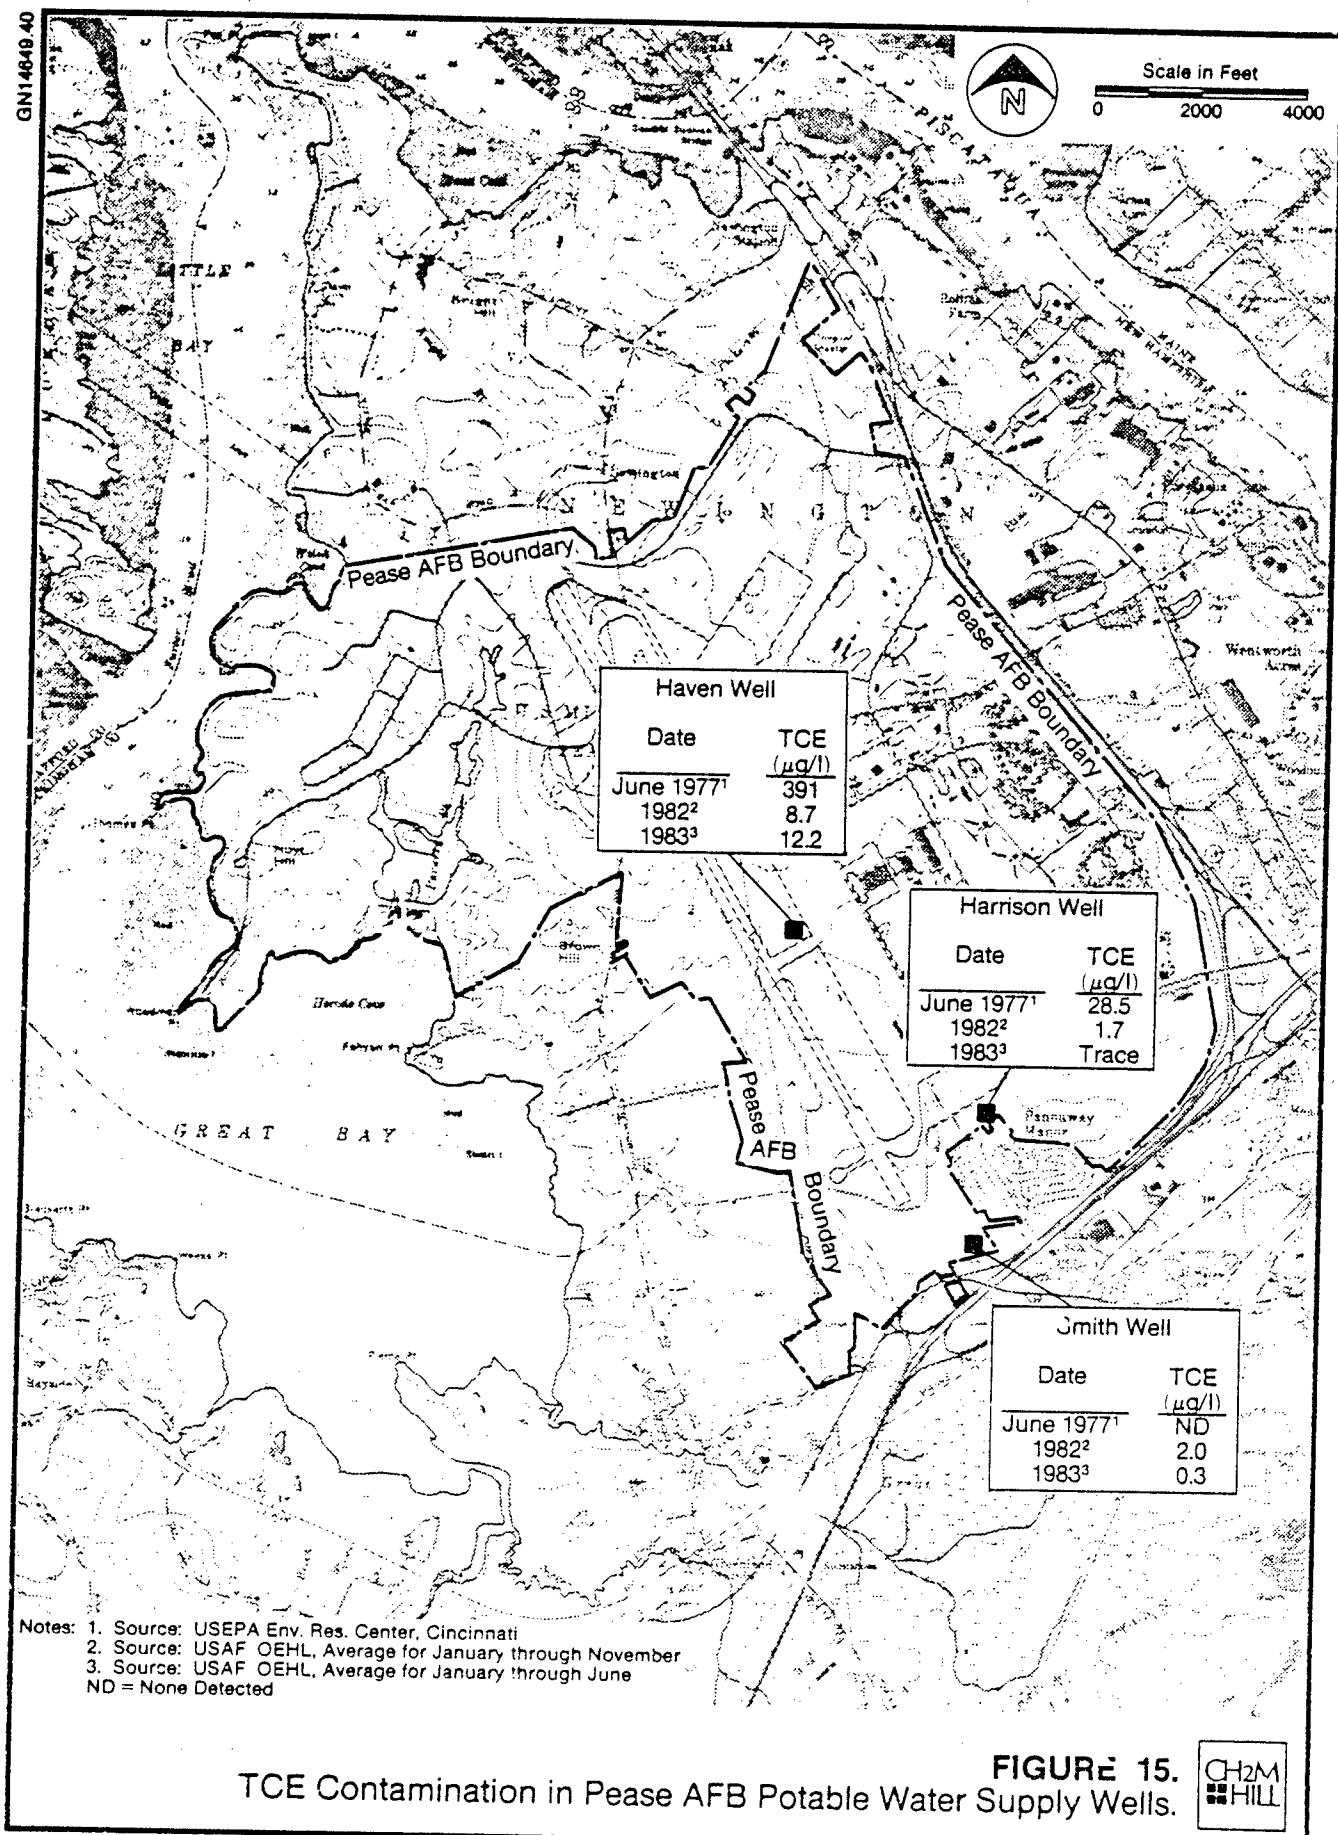
DC Hangar (Building 227) and in Building 120. An interviewee indicated that a common practice was to dispose of waste TCE in the washrack drain in Building 227 which was connected to the storm drain which discharged to Great Bay. This confirms the industrial area storm drainage system as a suspect source of the ground-water contamination. This same interviewee reported that TCE was sometimes taken to construction rubble Site No. 1 (Site No. 9) for disposal. This occurred for a short time in 1958 to 1959. Another interviewee reported that mixed waste oil and solvents, possibly containing TCE, was sometimes used in the past for dust control on dirt roads in the industrial shop area. In general, past disposal of TCE solvent to the industrial area storm drains and general spillage of TCE on the ground surface outside the shops makes this area, referred to as the Industrial Shop/Parking Apron Zone (Site No. 15), a likely source of ground-water contamination. The flightline shop area, parking apron, and runway are also located directly over the recharge area for the base water supply aquifer, and the Haven well is located within 1,500 feet downgradient of the nearest industrial shops.

Due to the potential health hazard of TCE contaminated drinking water, Pease AFB is nearing completion of a new water treatment plant which will use activated carbon and diffused aeration to remove TCE from the ground-water supply. This decision was made after consideration of available water supply alternatives, and was determined to be the most feasible option for the base. The TCE concentrations in the main supply wells have decreased significantly since 1977 (Figure 15) and generally occur in the 10 ppb range in the Haven well and small to trace amounts in the Smith and Harrison wells. In spite of the decreasing TCE concentrations, the new water treatment plant is necessary because of (1) the extreme vulnerability of the

FIGURE 15. TCE Contamination in Pease AFB Potable Water Supply Wells.

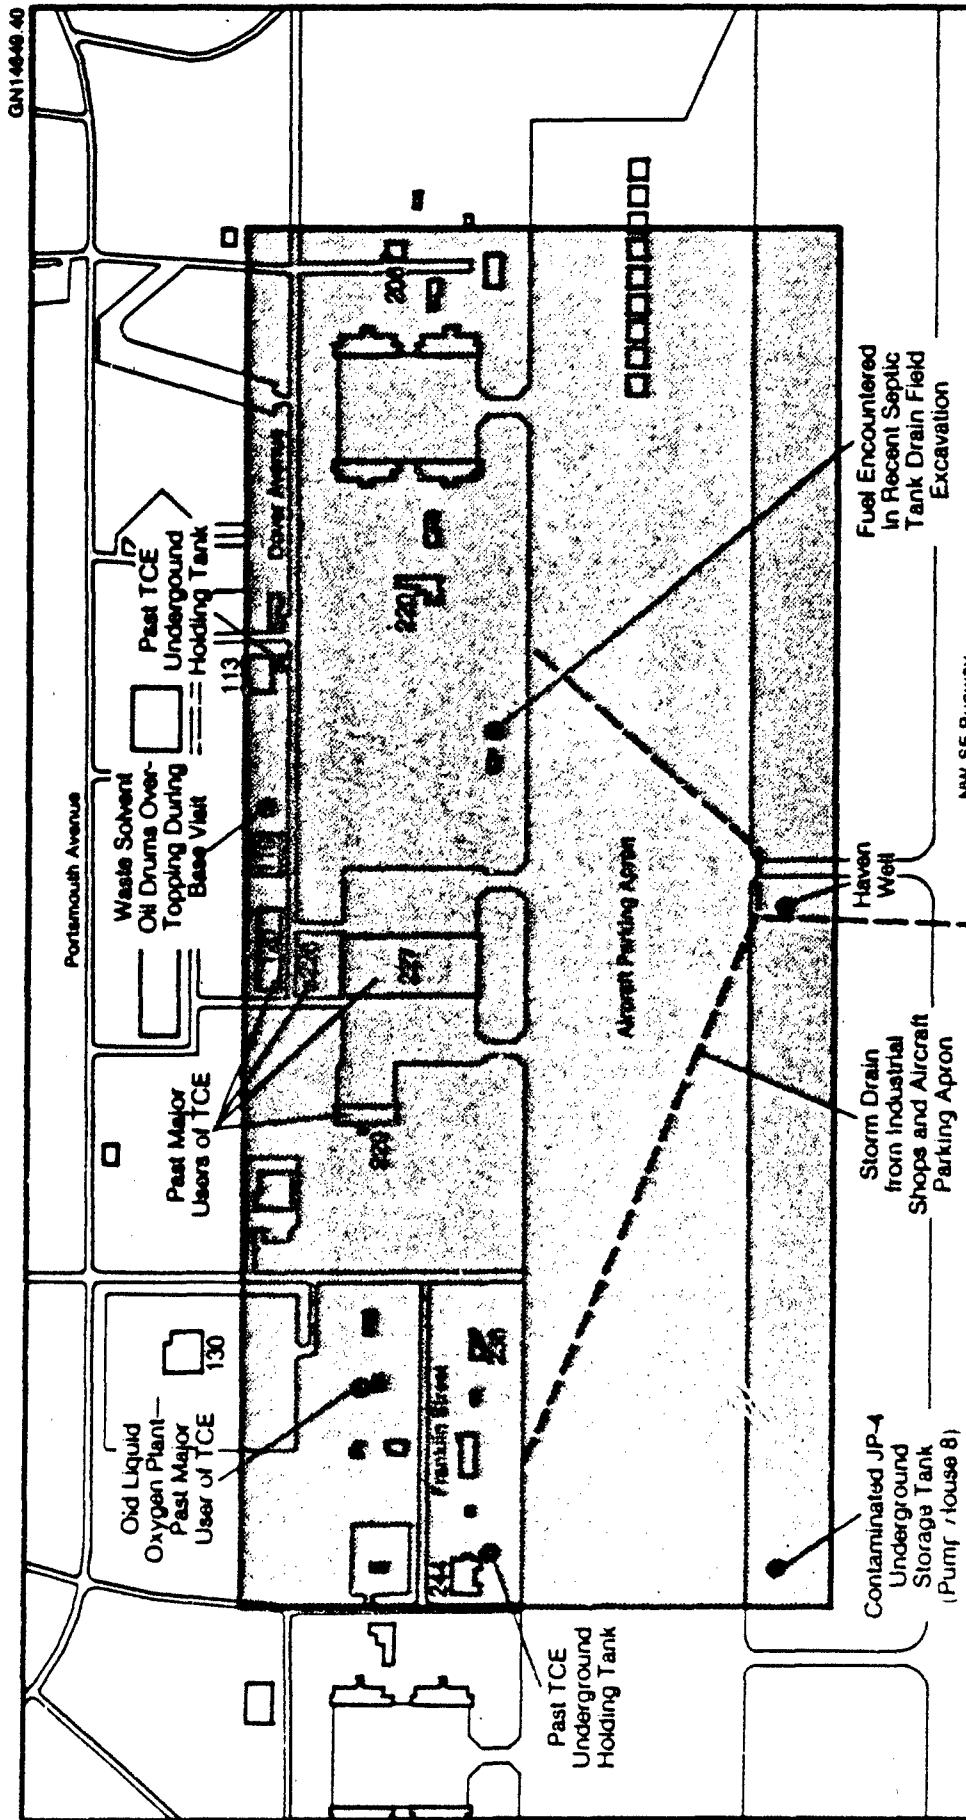
Site No. 15 is an area containing most of the flightline shops, hangars, and aircraft parking apron-refueling areas (see Figure 18). Over the years, this area has been the site of numerous small flightline spills, spent solvent and waste oil spills, and disposal of shop generated wastes into storm sewers. For a detailed

FIGURE 18. Site No. 15—Industrial Shop/Parking Apron Zone.

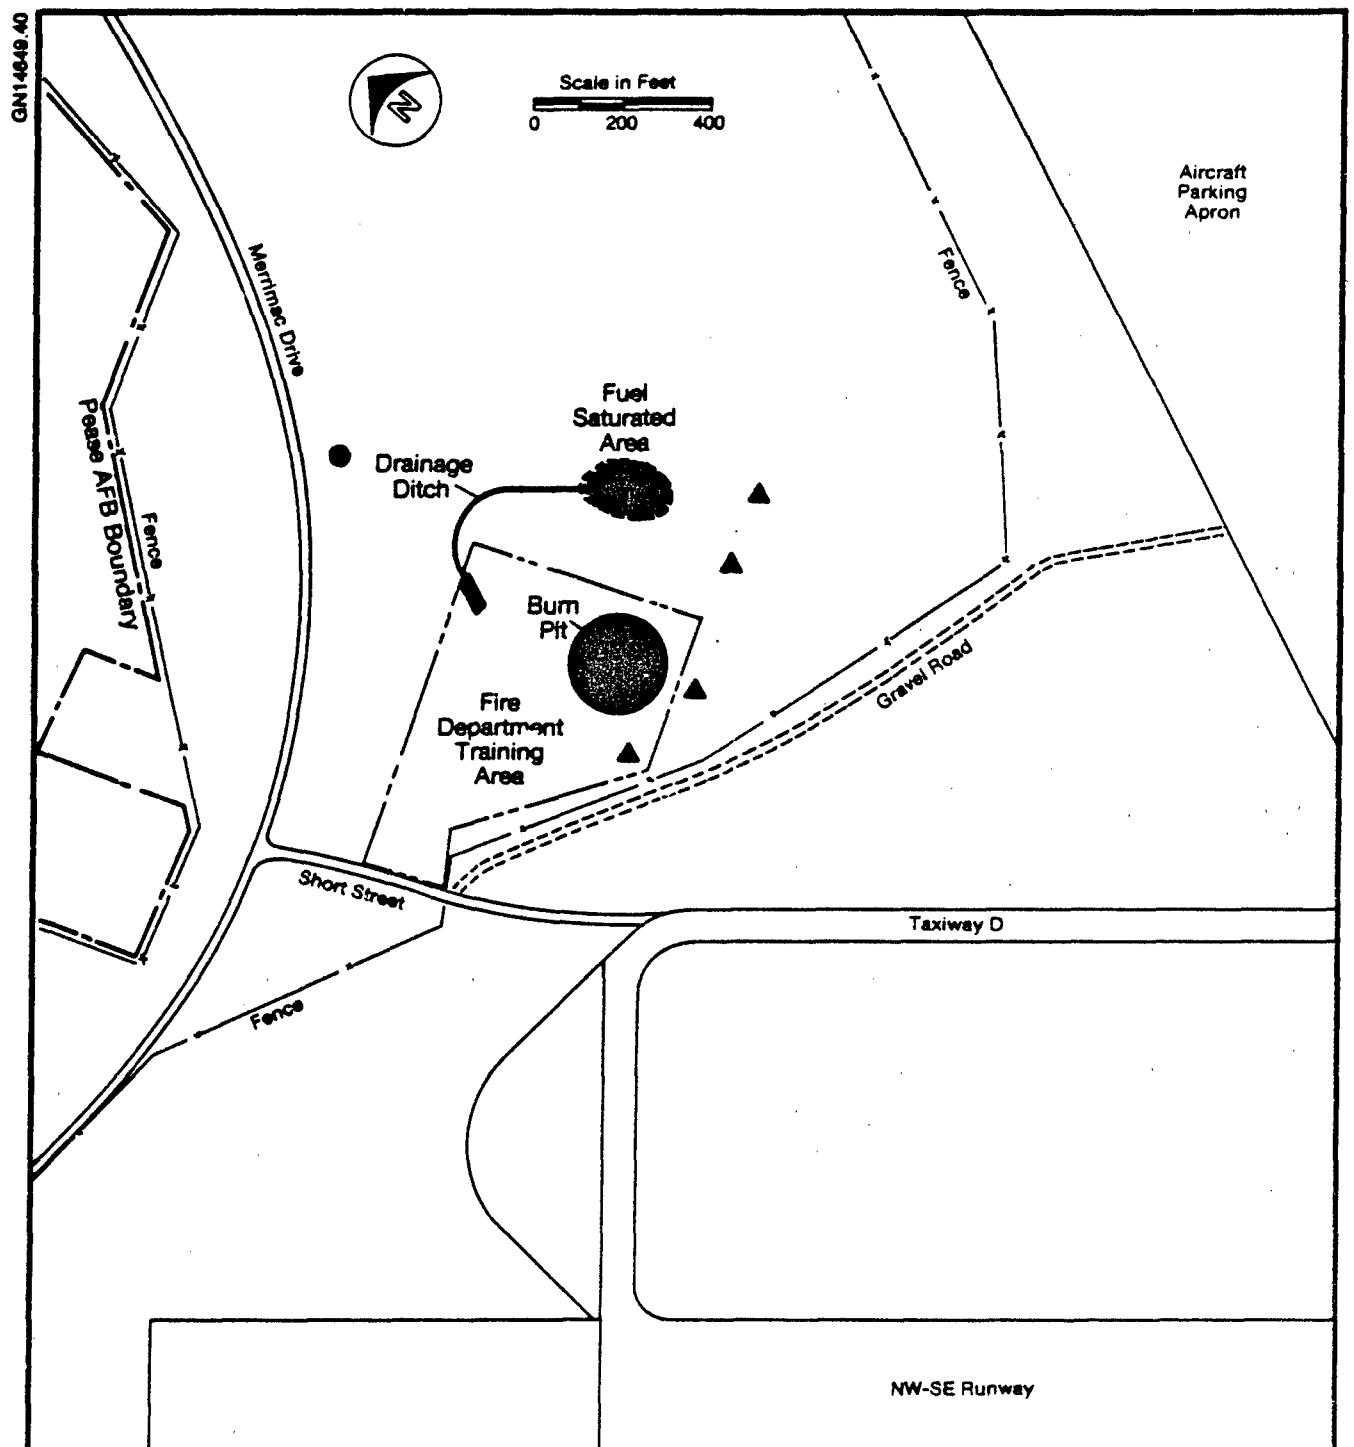
FIGURE 19.
Recommended Preliminary Sampling Locations for Site No. 8—
Fire Department Training Area No. 2.

migrating from Site No. 8. The well should be drilled to bedrock (approximately 30 feet) and screened throughout the saturated ground-water zone (approximately 10 to 30 feet). Each well should be sampled on two occasions, at least 30 days apart and analyzed for volatile organic compounds (VOCs), oil and grease, and the other parameters listed in Table 10. The VOC scan includes specific organic compounds, such as TCE, benzene, toluene, and xylene, which are not readily biodegradable components of solvents and fuels. The oil and grease analysis is an indirect indication of gross fuel contamination. In addition, the wells should be sampled in the field by color sensitive tape or liquid column sampler to determine the possible presence and estimated thickness of a floating fuel lens in the ground water in this area.

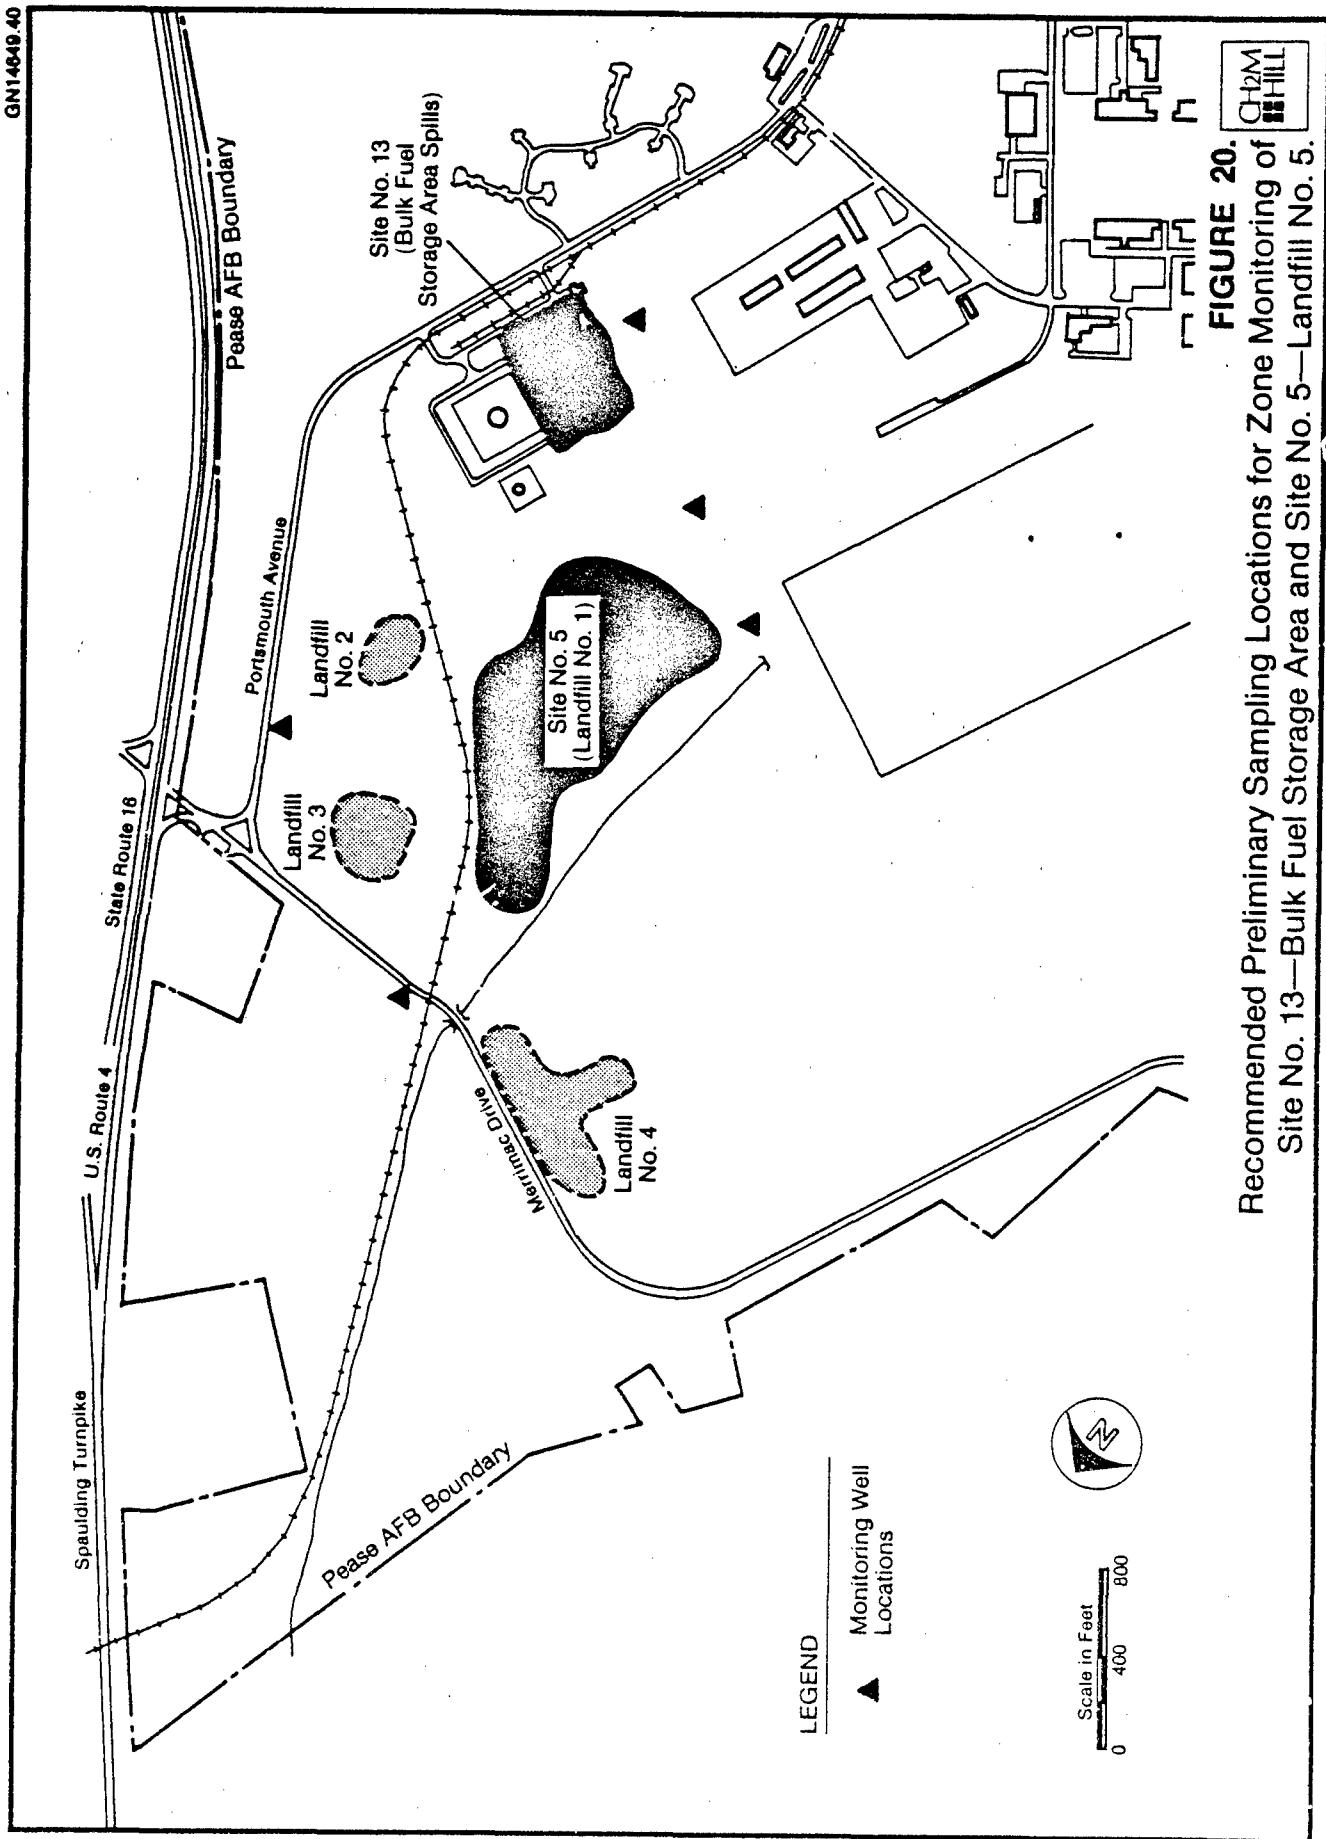
FIGURE 20.
Recommended Preliminary Sampling Locations for Zone Monitoring of
Site No. 13—Bulk Fuel Storage Area and Site No. 5—Landfill No. 5.

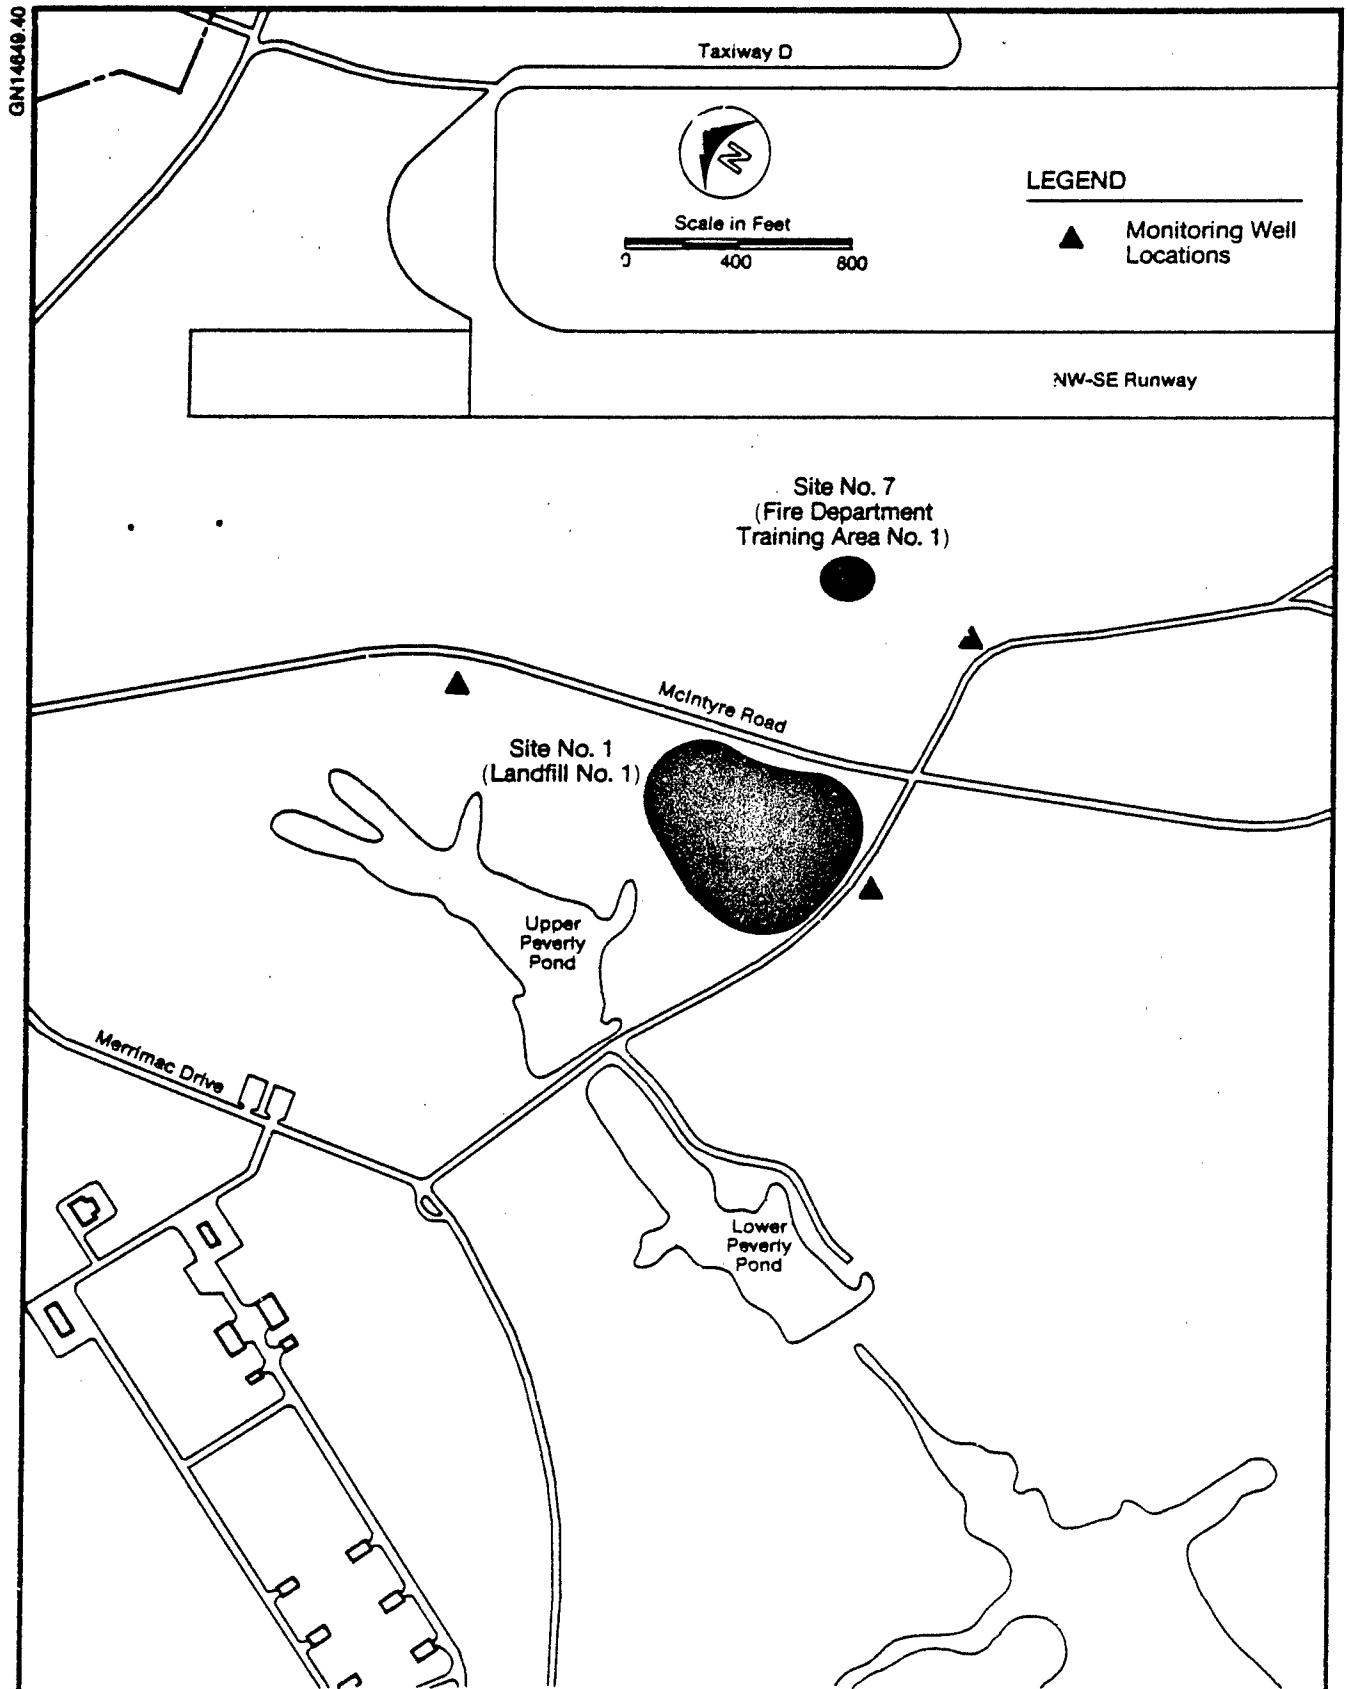
FIGURE 21.

Recommended Preliminary Sampling Locations for Zone Monitoring of
Site No. 1—Landfill No. 1 and Site No. 7—Fire Department Training Area No. 1.
